**CALTRANS ENGINEERING SERVICE CENTER
POST EARTHQUAKE INVESTIGATION TEAM REPORT**

**THE HECTOR MINE EARTHQUAKE
OF OCTOBER 16, 1999**

Post Earthquake Investigation Team Report

Performance of Bridges during the Hector Mine Earthquake **of October 16, 1999**

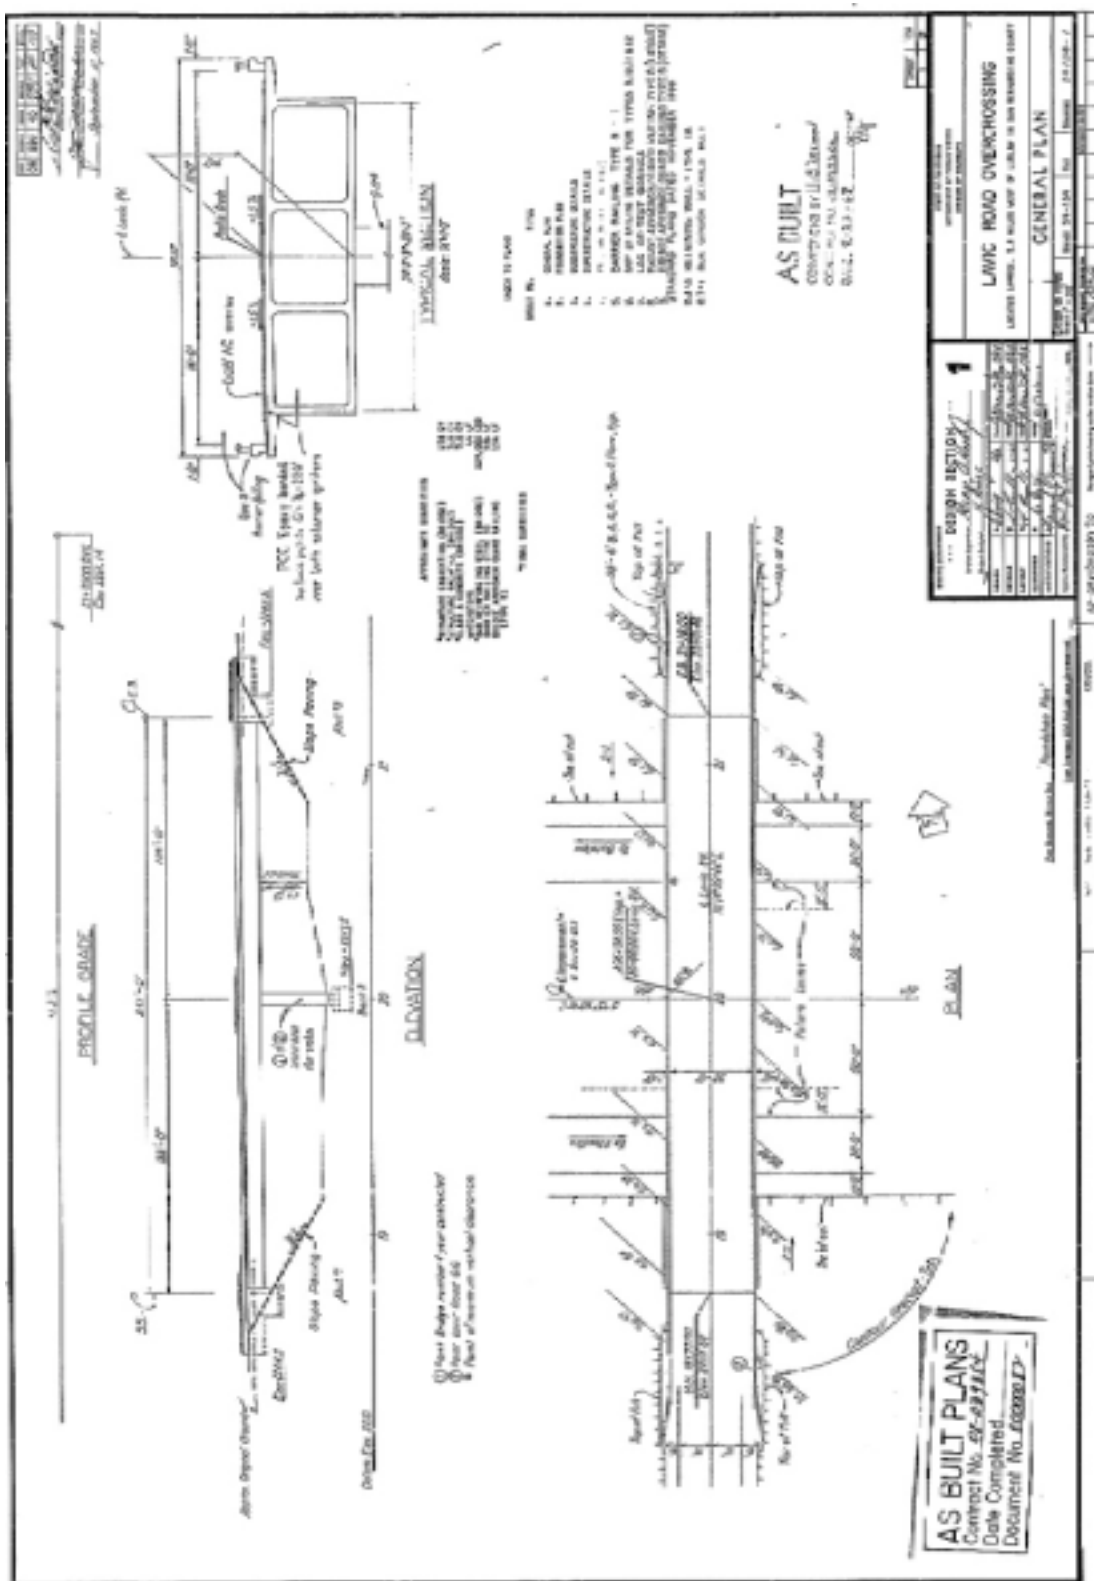
Figure 5. Lavic Road Overcrossing General Plan.

Lavic Road OC sustained moderate damage during the Hector Mine earthquake. The bridge is a two span reinforced concrete box girder with a single column bent (See General Plan, Figure 5). The damage was limited to the abutments. An inspection of visible sections of the column indicated no signs of cracking and/or distress. The bottom of the column was not inspected, as it is about seven to eight feet below the ground level. The structure experienced movements that resulted in the final displacements of 3" longitudinally, and about 2.5" to 3" in the transverse direction (Refer to Figure 7 and 8). The approach embankments settled approximately ½" to 2".

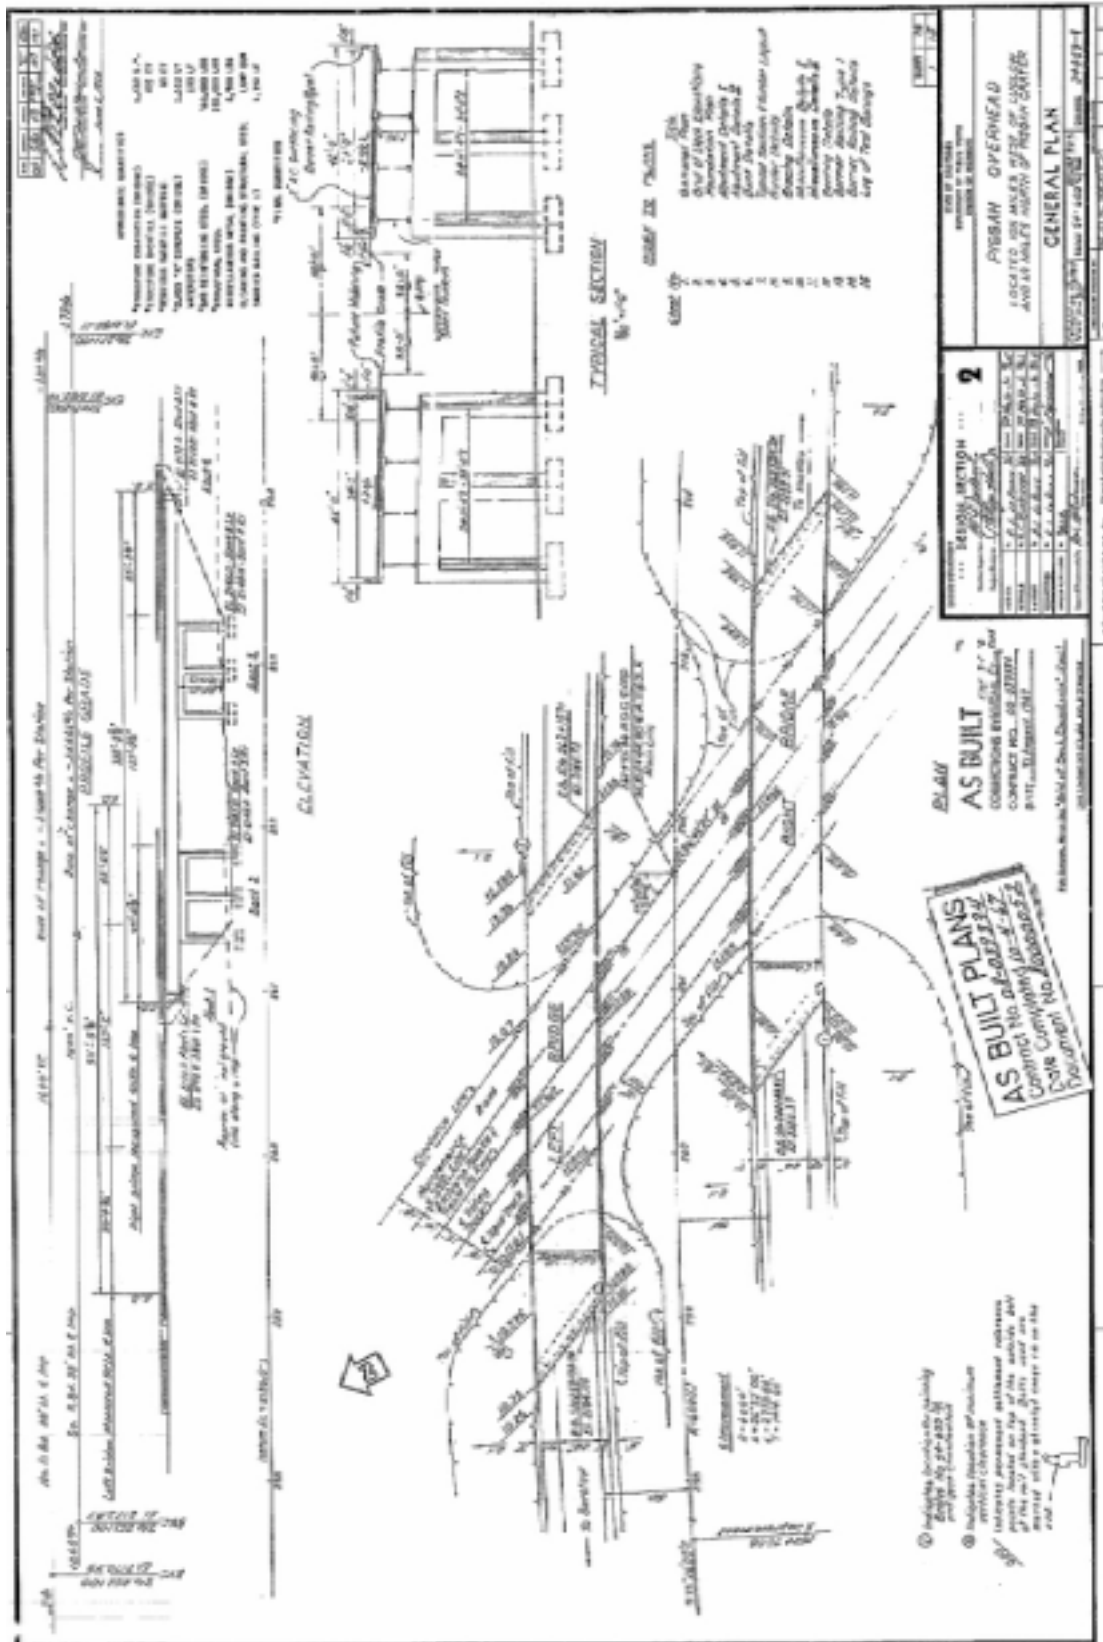
Figure 16. Pisgah Overhead L / R General Plan.

Pisgah Overhead (Left and Right Structures) are two parallel, three (3) span steel plate girder bridges with composite 'Cast-In-Place' concrete slabs (See Figure 16, General Plan). Asphalt Concrete (AC) overlay is placed on both structures. Both bridges have a large skew of about 55 degrees. The earthquake damage was mostly restricted to the abutment locations. The west abutments sustained more damage than the east abutments. The damage is due to longitudinal and transverse movement of the bridges and the pounding of bridge barriers and decks to the adjacent barriers (Figure 15), decks, wingwalls and abutment walls. Damage was noted at the abutment expansion joints, at the sheared off wingwalls, and at cracked steel bearing pedestals.

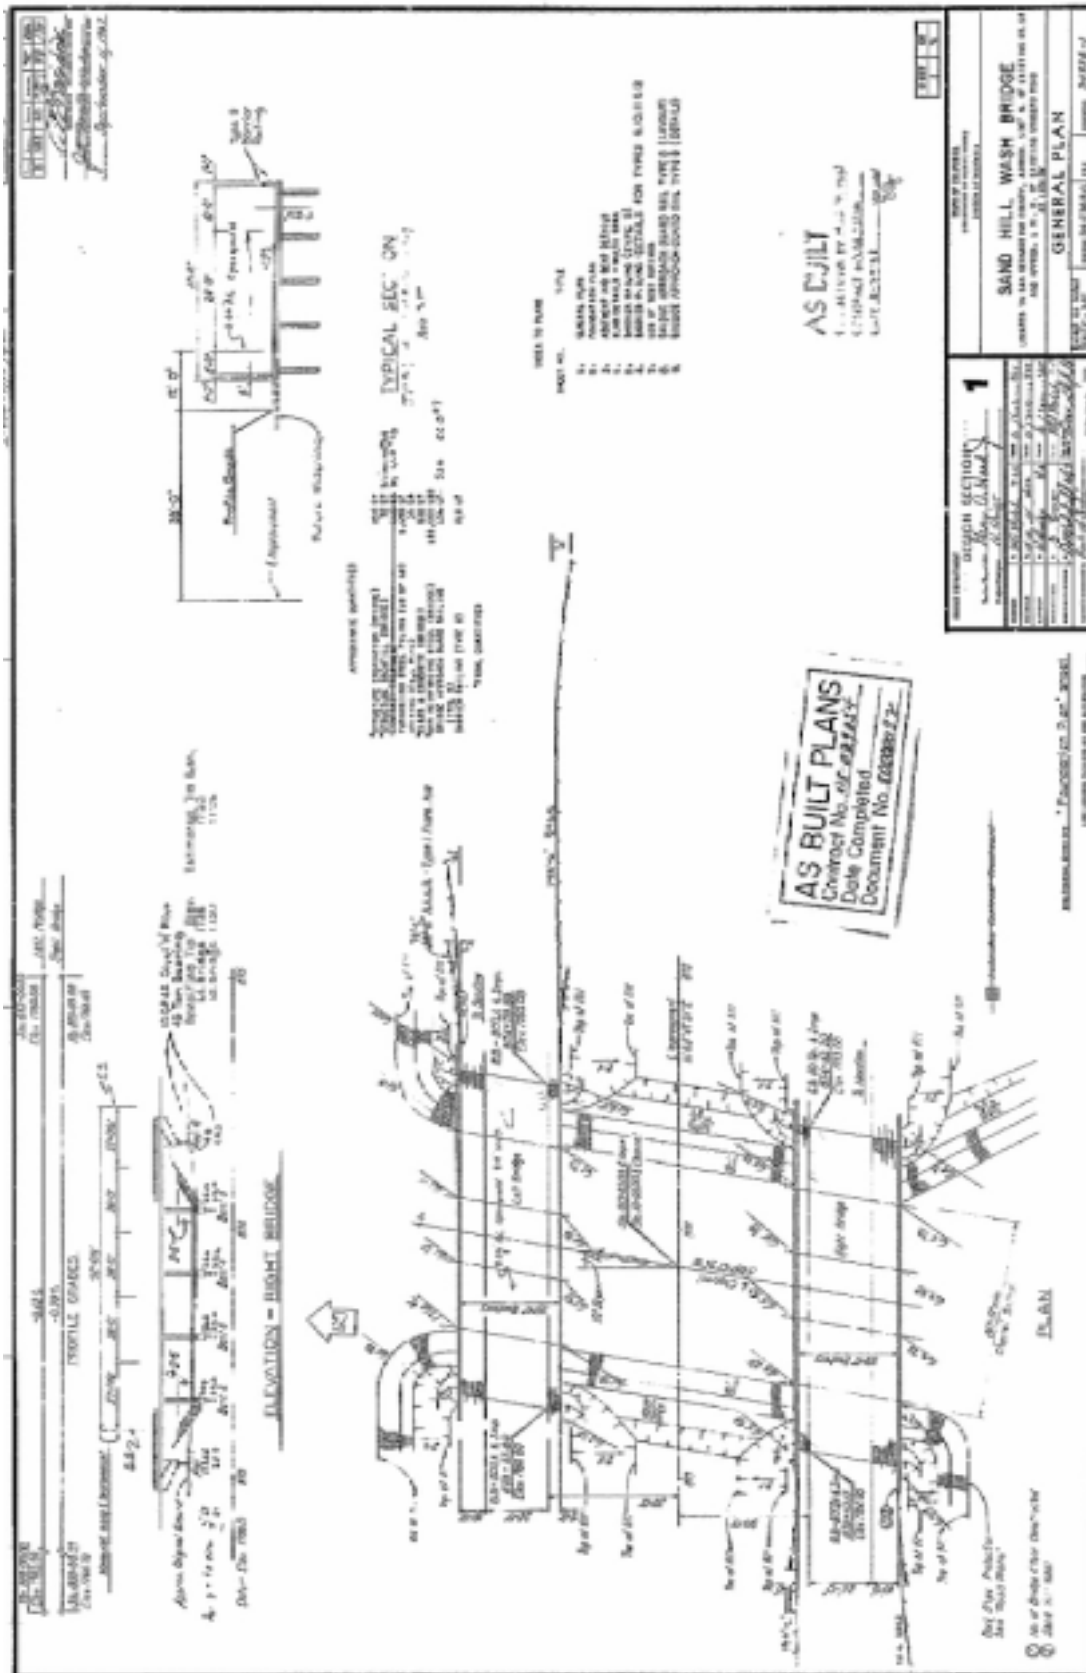
Figure 24. General Plan of Sand Hill Wash Bridges.

These bridges are also standard slab structures on pile extensions. The Sand Hill Wash bridges behaved similarly to the Argos Wash structures, only the described findings were smaller than in the case of the Argos Wash Bridges. It is our opinion that this was most likely due to more distance from the earthquake epicenter. The movements at the abutments were about two inches. There was no damage to these structures except minor concrete cracking. We could observe that the pile extensions had also moved in this case. However the size of cones formed in the sandy soil was smaller than in the case of Argos Wash Bridges. The cones extended only six inches from the face of the pile extensions (Figure 28).
